TECHNICAL REPORT REMR-CO-3

CASE HISTORIES OF CORPS BREAKWATER
AND JETTY STRUCTURES

Report 7

NEW ENGLAND DIVISION

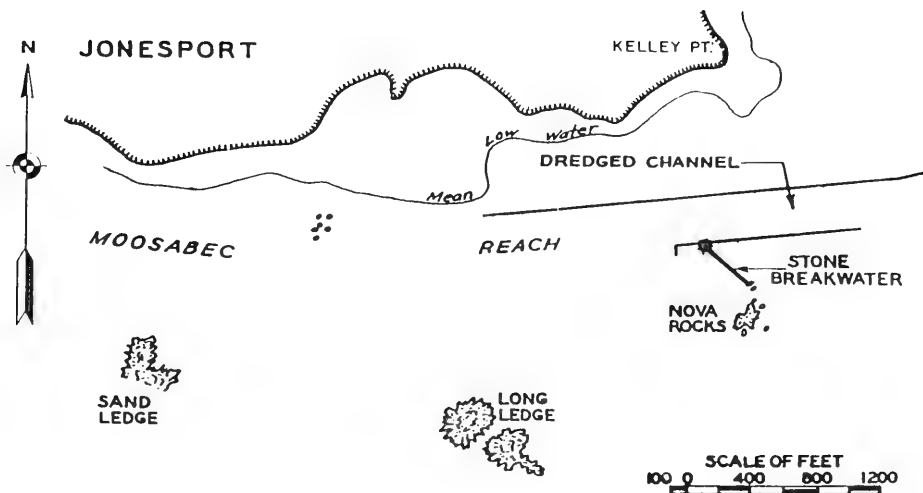
Figure 4. Plan view of breakwater at Moosabec Bar, Maine

Date(s)	Construction and Rehabilitation History
1891	As part of channel improvements, a 400-ft-long rubble-mound breakwater was constructed (Figure 4).
1892	
1962-1977	Inspections of the breakwater indicated several small breaks along the top, but its overall condition was considered fair to good.
1986	The structure has no known repair history.

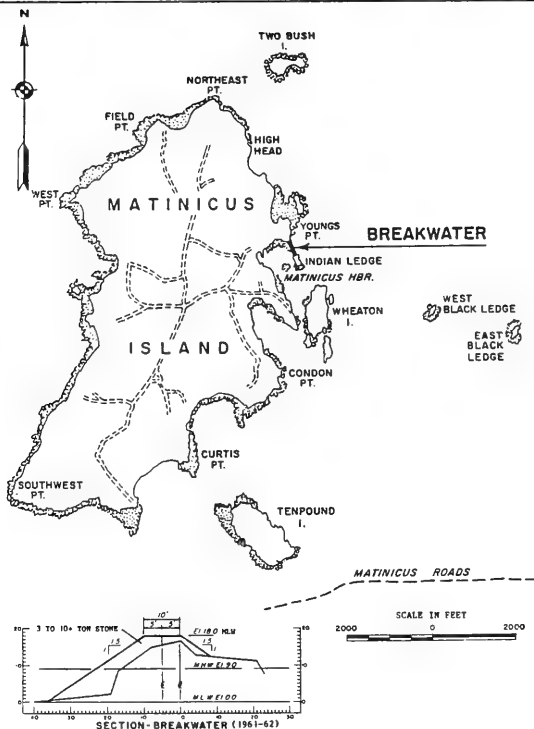
Figure 6. Location map of breakwater at Matinicus Harbor, Maine

Date(s)	Construction and Rehabilitation History
1911	A 450-ft-long rubble-mound breakwater was constructed (Figure 6) using 9,080 tons of stone for a total cost of \$11,800.
1934	Repairs were made to the structure. Details of the work are not known.
1961-1962	The breakwater was rehabilitated using 5,930 tons of stone at a cost of \$103,000. The repair geometry (Figure 6, inset) had 1V:1.5H side slopes, a 10-ft top width, and a +18 ft mlw crown elevation. Seventy-five percent of the stone by weight was a minimum of 10 tons, and the remainder was a minimum of 3 tons. The cover stones weighed a minimum of 10 tons.
1967-1977	Inspections indicated the breakwater was in good condition with some displacement of cover stone on its seaward face.

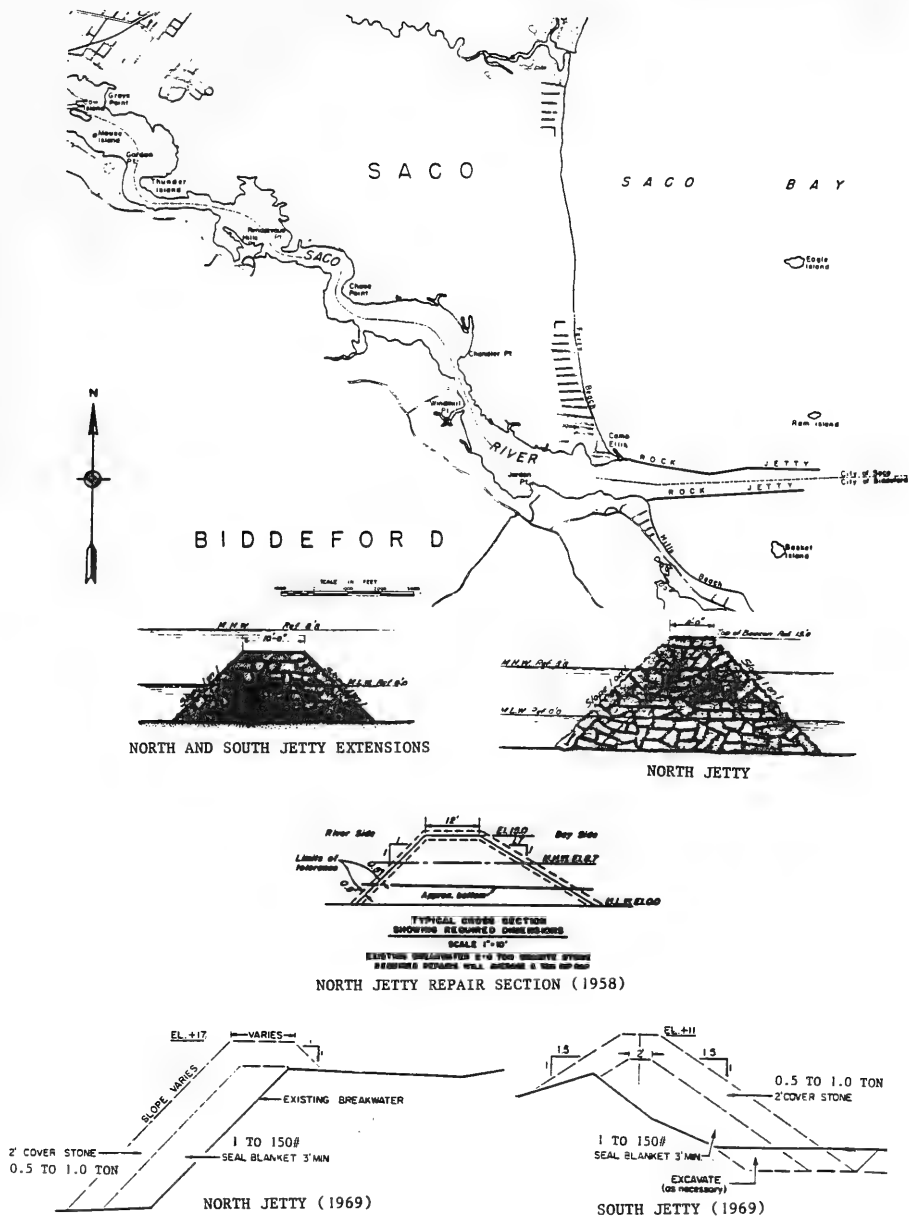
Figure 12. Plan view and typical sections of Saco River Jetties, Saco, Maine

Date(s)	Construction and Rehabilitation History
1971	About 650 ft of shoreline revetment was placed landward of the south jetty terminus. The cost for placing 7,350 tons of stone and 3,000 cu yd of sand fill was \$93,100.
1983	An inspection indicated the south jetty was in good condition. The 1968 north jetty repair section was in good condition, but the remainder of the jetty was in poor condition.

Date(s)	Construction and Rehabilitation History
1873- 1912	During this period (noninclusive) the north (Sharp's Ledge) and south (Hills Beach) jetties were constructed to lengths of 4,100 and 4,800 ft, respectively. The north jetty had an elevation of +15 ft mlw and an 8-ft crown width. The south jetty top elevation and width were +5.5 ft mlw and 10 ft, respectively. Jetty side slopes were 1V:1H. The jetties are roughly parallel and spaced 700 ft apart (Figure 12, present plan view). The south jetty extended approximately 1,600 ft bayward of the north jetty. The mean tide range is 8.8 ft.
1927- 1930	The north jetty was extended 1,600 ft bayward. The design cross section was identical to that used on the south jetty. The extension resulted in adjacent bayward ends of the jetties. Repairs were made on the outer 1,600 ft of the south jetty. The repair cross section was identical to the original design. Extension and repair costs totaled \$53,800 with approximately 18,100 and 2,450 tons of stone placed on the north and south jetties, respectively.

1934- 1938	The north jetty was extended 900 ft bayward, and at the landward end a 160-ft section was repaired. The extension gave the jetty a total length of 6,600 ft, and the design cross section was similar to that of the previous extension. The design cross section for the landward repairs specified a +18 ft mlw elevation, a 12-ft crown width, and 1V:1H side slopes.
1958	The landward 700 ft of the north jetty were repaired to a crown elevation of +15 ft mlw, a 12-ft crown width, and slopes of 1V:1H and 1V:1.7H on the channel and bay sides, respectively. Stone size varied from 0.5 to 7 tons or more, with 75 percent of the stone averaging more than 5 tons apiece. Prior to the repairs, existing center-line elevations varied from +9 to +15 ft mlw. A total of 5,100 tons of stone was placed for a cost of \$38,000.
1969	Repairs were made at the landward ends of the jetties by placing a seal blanket of 1- to 150-lb stone and 0.5- to 1.0-ton cover stone. Repair sections were 1,000 and 1,100 ft in length on the north and south jetties, respectively. The repair geometry was placed on the bayside slope of the existing jetty sections, with a minimum blanket thickness of 3 ft and a 2-ft cover layer. The north jetty design geometry had a +17 ft mlw crown elevation, various crown widths from 3 to 12 ft, a variable bayside slope matching the existing slope, and a 1V:1H channel side slope. The south jetty design geometry consisted of a +11 ft mlw crown elevation, 3-ft crown width, and 1V:1.5H side slopes. The cost for placing 16,600 tons of stone was \$199,000.

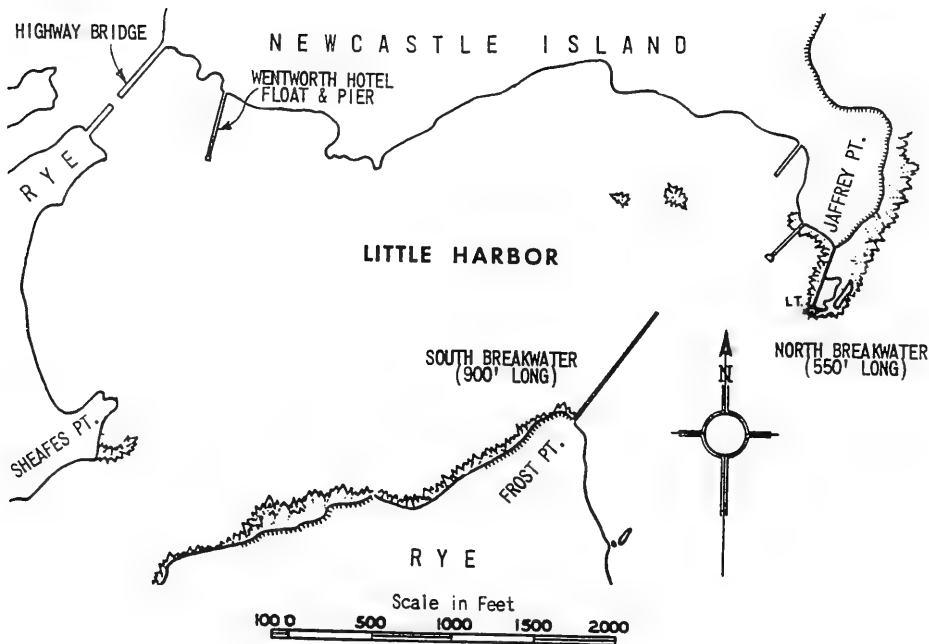
Figure 16. Plan view and cross sections of breakwaters at Little Harbor, N.H.

<u>Date(s)</u>	<u>Construction and Rehabilitation History</u>
1894- 1903	Two rubble-mound breakwaters were constructed to lengths of 550 and 900 ft on the north and south sides of the entrance to Little Harbor (Figure 16).
1905	Minor repairs were made using 476 tons of stone.
1959- 1974	Based on several visual inspections, the jetties were considered to be in poor condition.
1975	Seaward sections of the north and south jetties, 350 and 850 ft long, respectively, were repaired using 4 to 7-ton stone. The design cross section (Figure 16, inset) had a +12 ft mlw crown elevation, a 12- or 14-ft top width, and 1V:1.5H side slopes. The side slope on the seaward facing quadrant of the breakwater heads was 1V:2H. The cost for placing 7,800 tons of stone was \$159,500.
1983	An inspection showed that the north jetty had a few small areas of displaced stone, and the south jetty had substantial damage which was subsequently repaired along the seawardmost 150 ft.

1985	Visual inspection indicated the breakwaters were in good condition.

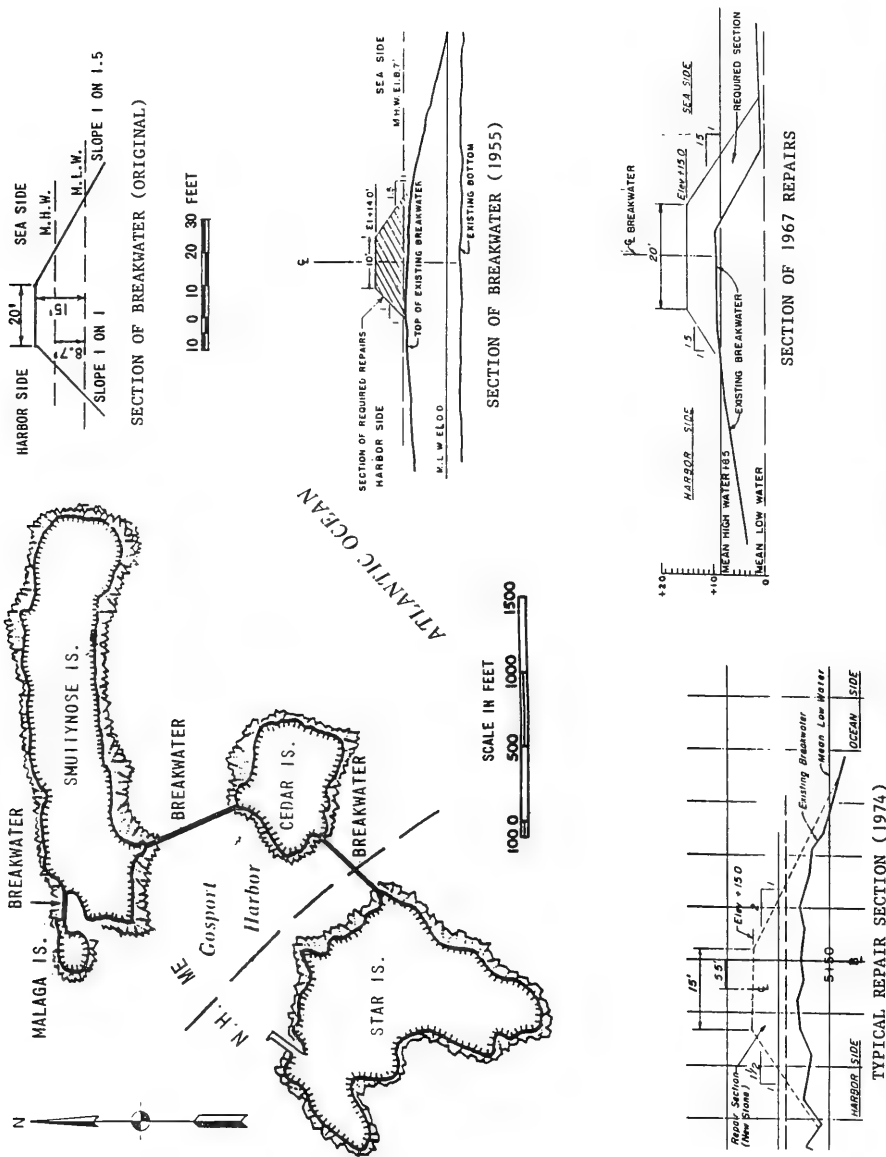
Figure 17. Breakwaters at Isles of Shoals, Maine, and N.H.

1967	The Cedar Island to Star Island breakwater was inspected and found to be in poor condition. Plans and specifications were prepared for repairing a 500-ft section adjacent to Star Island. But, due to contract bids substantially above the Government estimate, no contract was awarded. The plans show the breakwater to be approximately 650 ft long with a 200-ft dogleg section adjacent to Star Island, apparently adding 120 ft to the original length. Existing center-line elevations were typically from +9 to +13 ft mlw along the proposed repair section.
1974	About 575 ft of the Cedar Island to Star Island breakwater, adjacent to Star Island, were repaired using 6- to 10-ton stone. Prior to repair, typical center-line elevations varied from +6 to +10 ft mlw. The stone was placed to an elevation and top width of +15 ft mlw and 20 ft, respectively. Slopes were 1V:2H and 1V:1.5H on the sea and harbor sides, respectively. In addition to 14,000 tons of new stone, displaced stone on the harbor side was used in reconstructing the lower portions of the breakwater. The repair cost was \$665,000.

1983	Visual inspections of the Cedar Island to Star Island and Cedar Island to Smuttynose Island breakwaters indicate the former was in good condition, while the latter was in fair to poor condition with a significant amount of damage along its midsection.
1986	Present conditions of the breakwaters are not known.

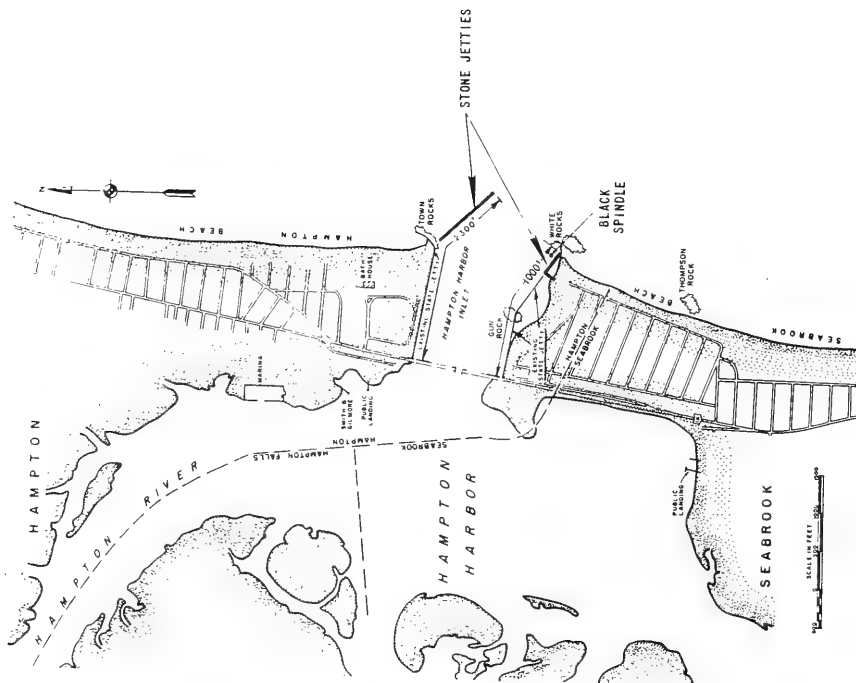
Figure 18. Jetties at Hampton Harbor, N.H.

1969	Plans and specifications were prepared for north jetty repairs, but no work was done at this time. The outer 110 ft was in an unraveled condition with typical center-line elevations from +3 to +10 ft mlw.
1973 1974	The north jetty extension was repaired. Prior to repair, the jetty had numerous void spaces and gaps along its entire length. The seaward 300 ft was in a severely unraveled state with typical crest elevations between 0 and +10 ft mlw. The seaward 490 ft was brought up to +12 ft mlw with 6- to 9-ton stone placed to an 8- to 10-ft crown width and 1V:1.5H side slopes. The jetty head semicircle had a 1V:2H side slope. The landward 55 ft was rebuilt to the 1966 design geometry with 2- to 3-ton stone. Void areas on the remaining jetty section were repaired with 2- to 3-ton stone. A total of 8,380 tons of stone was placed at a cost of \$165,400.
1981	Repairs to the north jetty consisted of placing 4- to 9-ton stone on a 535-ft section at its seaward end. The design geometry was essentially identical to the earlier 1973-74 repair geometry. Before the repairs, typical crown elevations varied from +8 to +12 ft mlw with most of the subsidence occurring at the seaward end of the repair section. A total of 1,290 tons of stone was placed at a cost of \$109,905.

1984	The jetties were inspected and found to be in excellent condition. Figure 19 is an aerial photograph of the jetties taken on 16 October 1984.

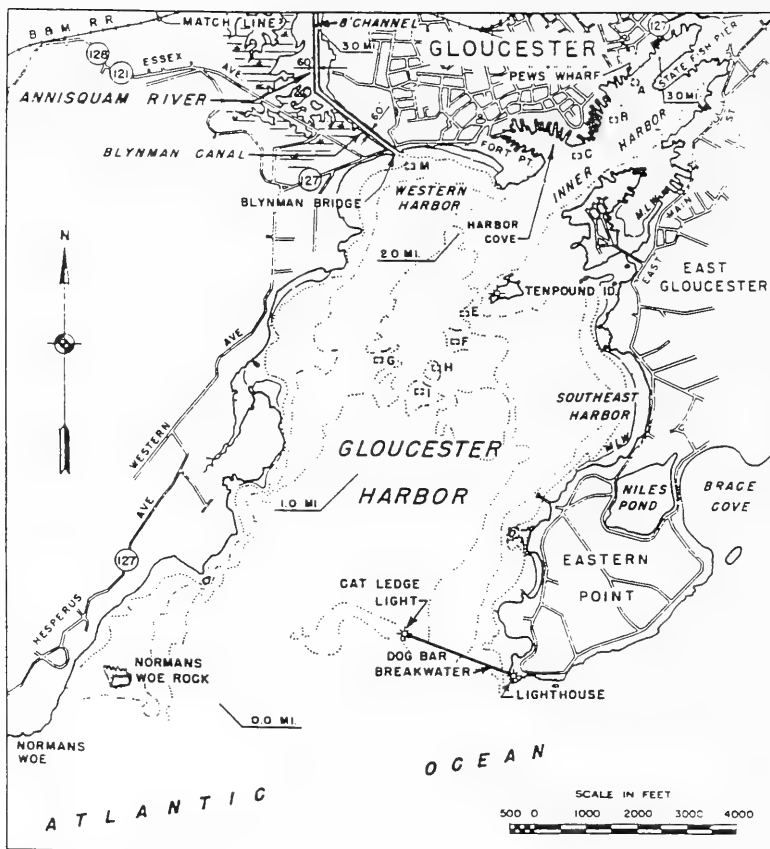
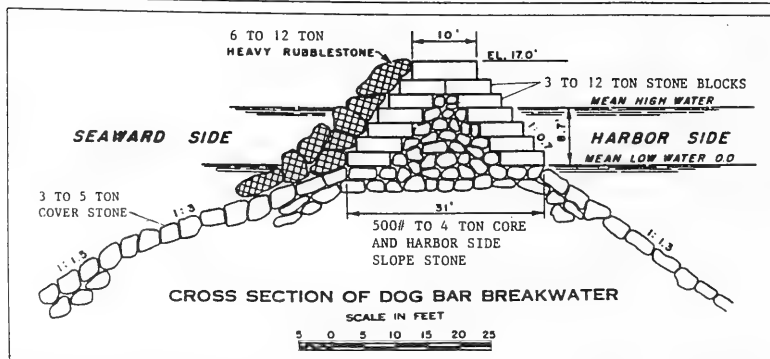
Figure 23. Plan view and typical section of Dog Bar breakwater at Gloucester Harbor, Mass.

1967- 1978	Breakwater inspections, taken over this period, showed a gradual deterioration of the sea-side armor stone at several locations. Most of the damage was on the outer half of the breakwater.

1931- 1940	Minor repairs were made to the superstructure in 1931, 1933-34, 1935, 1939, and 1940. The work (approximate totals in parentheses) included resetting (2,000 tons) and replacing (1,000 tons) stone blocks, placing rubble stone (7,000 tons) on the seaward face (Figure 23, inset), and placing iron pins (700) on the harbor side stone blocks to act as buttressing for the upper courses of stone. The total repair costs were \$35,700.
1962	A breakwater inspection showed the stone block superstructure was in good condition with only localized areas needing repair. The sea-side armor stone, placed during 1931-40, was in poor condition with several large cavities and a general subsidence along the entire breakwater length.
1965- 1966	Repairs were made to the breakwater superstructure, and 10,920 tons of 6- to 12-ton armor stone were placed on the sea side between 0+00 (landward end) and 21+85. Displaced stone blocks were reset from 1+14 to 1+72 and 9+96 to 10+22. Total cost of the repairs was \$96,400.

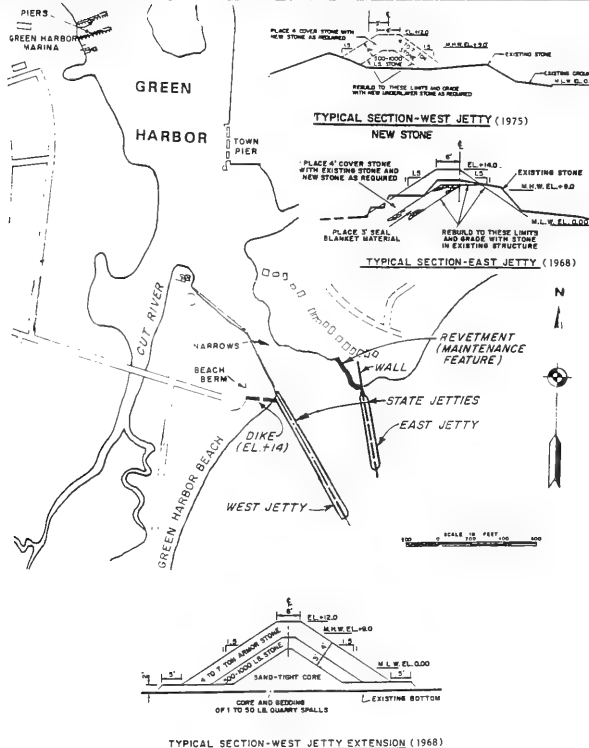
Figure 25. Plan view and cross sections of jetties at Green Harbor, Mass.

<u>Date(s)</u>	<u>Construction and Rehabilitation History</u>
1898- 1899	Two rubble-mound jetties were constructed by the Commonwealth of Massachusetts at the entrance to Green Harbor and have been repaired periodically since that time (Figure 25, present plan view). Information on the original jetty lengths was not found.
1931	The state constructed 196 ft of concrete wall at the east jetty's landward end.
1965	The Federal government adopted the project under authority of the River and Harbor Act of 1960.
1968- 1969	Repairs were made to seaward sections of both jetties, and the west jetty was extended 200 ft seaward (Figure 25, insets). The east and west jetty repair sections were 494 and 650 ft long, respectively, and consisted of placing a 3- to 4-ft-thick seal blanket of 1- to 50-lb quarry spalls on the seaward slope of the jetties followed by a 2- to 4-ft-thick layer of cover stone. The cover stone was from 4 to 7 tons and 0.5 to 4 tons on the east and west jetty repair sections, respectively. The design geometry, including the west jetty extension, called for a 6-ft crown width, 1V:1.5H side slopes, and crown elevations of +14 and +12 ft mlw on the east and west jetties, respectively. The west jetty extension was built up on a core and 2-ft-thick bedding layer of 1- to 50-lb stone, followed by a 3-ft-thick underlayer of 500- to 1,000-lb stone, and covered with 4- to 7-ton armor stone. The jetties' seaward ends had 1V:2H side slopes. A 175-ft-long dike of 0- to 25-lb stone was placed at the landward end of the west jetty repair section. The stone was placed to a 4-ft top width, 1V:2H side slopes, and a crown elevation increasing from +12 to +14 ft mlw in the landward direction. Prior to the repairs, crown elevations varied from +8 to +11 ft mlw and +6 to +13 ft mlw on the east and west jetty repair sections, respectively. The majority of the east jetty was in a severely unraveled state. Improvements cost \$149,000 using a total of 14,900 tons of stone.

Date(s)	Construction and Rehabilitation History
1972-1974 (cont.)	worst areas as low as +4 ft mlw. It was estimated that 1,000 and 500 tons of new and salvageable stone, respectively, were needed to repair the jetty.
1975	The seaward 525-ft section of the west jetty was repaired to the 1968-69 design cross section using 4- to 7-ton cover stone and 500- to 1,000-lb underlayer stone as needed (Figure 25, inset). The repairs were made for a total cost of \$40,000.
1977	An inspection indicated that the east jetty was in good condition but that the west jetty needed some armor stone reset.
1986	Yearly inspections indicate that the jetties are in good condition. For the purpose of this report, the lengths of the east and west jetties are considered to be 645 and 850 ft long, respectively (the 1968-69 improvements plus approximately 150 ft of concrete wall landward of the east jetty repair section).

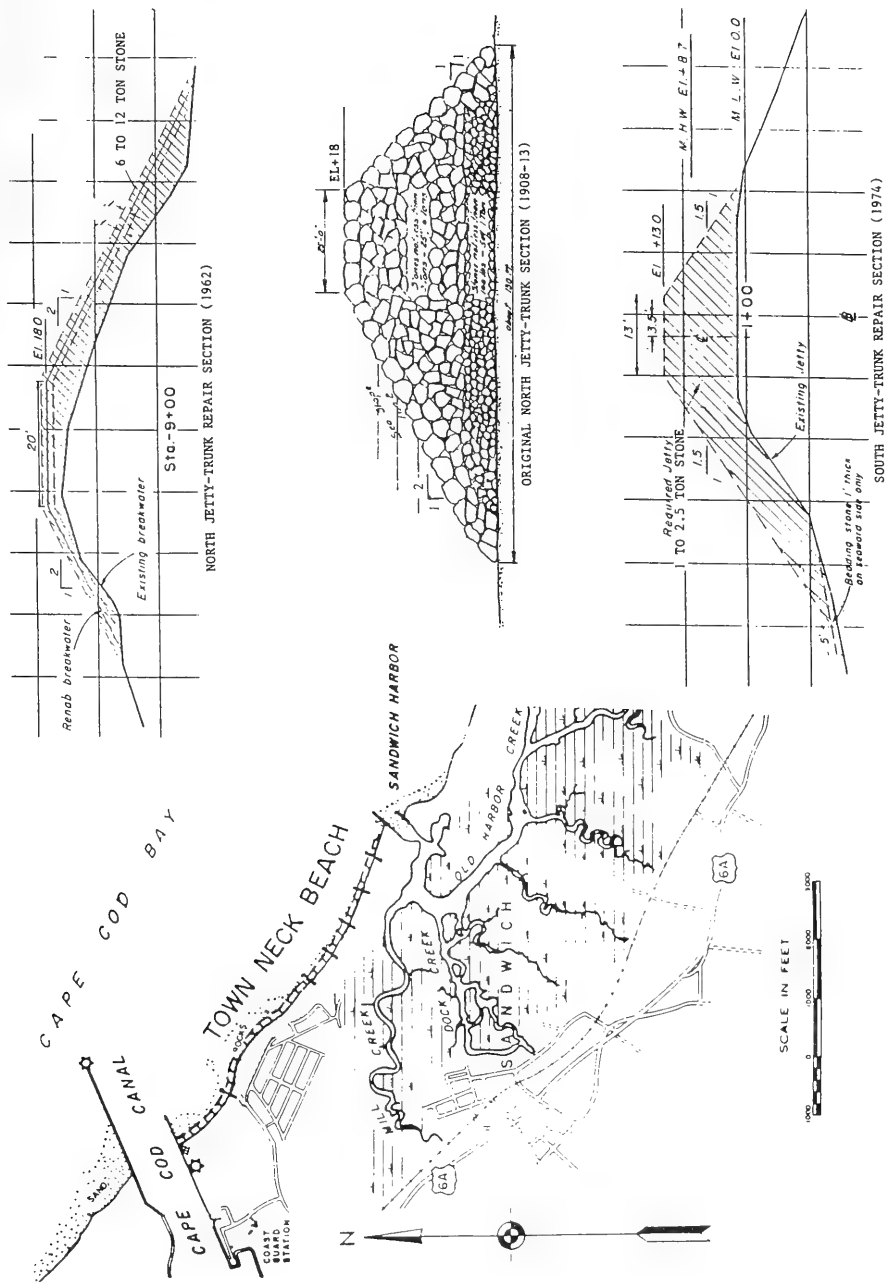
Figure 27. Plan view and typical sections of jetties at Cape Cod Canal, Mass.

1977	The jetties were visually inspected. The south jetty was found to be in good condition, while the north jetty needed repairs throughout its entire length.
1986	Recent yearly visual inspections indicated the jetties were in good condition.

1962-	The seaward 925 ft of the north jetty was rebuilt to +18 ft mlw. Stone 1963 placed on the structure weighed a minimum of 6 tons, except on the 125-ft-long head section, where the minimum size was 12 tons. The head section had a 25-ft crown width and a transition in side slopes from 1V:2H to 1V:3H in the seaward direction. A 20-ft crown width and 1V:2H side slopes were specified on the jetty trunk section. Prior to the repairs, typical crown elevations were from +14 to +18 ft mlw on the trunk section and from +7 to +18 ft mlw on the head section. The contract price for placing an estimated 20,000 tons of stone was \$260,000.
1967- 1974	Inspection reports indicate the north jetty was in good condition, while the south jetty was in poor condition with numerous voids and displaced slope stone along its entire length.
1974	The south jetty was rebuilt to +13 ft mlw. The rebuilt section was 690 ft long and terminated at the jetty's seaward end. Side slopes were 1V:1.5H. A 13-ft crown width and 5- to 7-ton stone were specified on the seaward 200 ft. The remaining section required a 10-ft crown width and 1- to 2.5-ton stone. A 1-ft-thick layer of bedding stone, 0 to 50 lb in size, was placed along the outermost 450 ft of the jetty's seaside toe. Prior to the repairs, crown elevations were typically from +3 to +8 ft mlw. The contract price for placing an estimated 15,500 tons of stone was \$224,800.

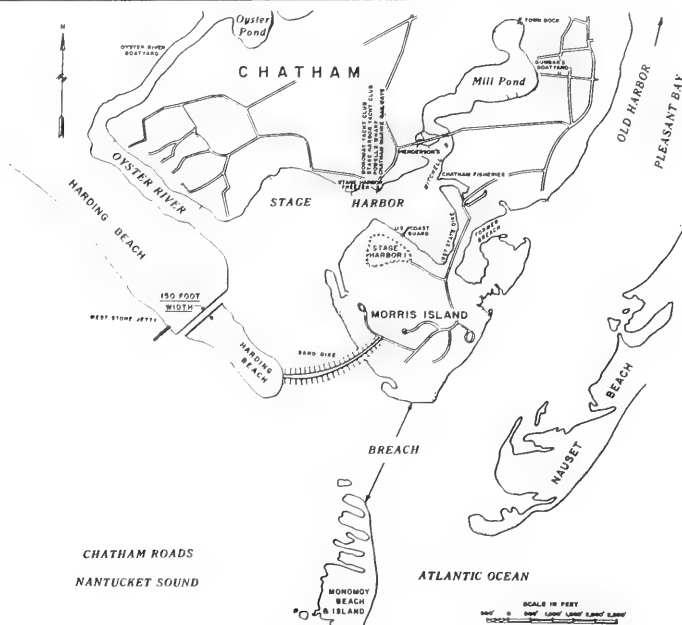
Figure 29. Plan view of Chatham Harbor Jetty, Chatham, Mass.

Date(s)	Construction and Rehabilitation History
1965	As part of improvements at Chatham Harbor, a 200-ft-long rubble-mound jetty was constructed on the west side of the entrance channel (Figure 29). The armor stone was approximately 0.5 to 2 tons in size, and the core stone varied from 0 to 500 lb (cross-section details not known). The cost for placing an estimated 1,375 tons of stone was \$13,750.
1967	The jetty was extended approximately 300 ft landward via rubble-mound and stone revetment. Erosion of the adjacent shoreline had resulted in flanking of the jetty's inshore end. The rubble-mound section was built using 0.5- to 2-ton cover stone and 0- to 50-lb core stone. The contract cost for placing 945 tons of stone in the extension was \$12,950.
1968-1977	Visual inspections indicated the jetty was in excellent condition.
1986	The present condition of the jetty is not known.

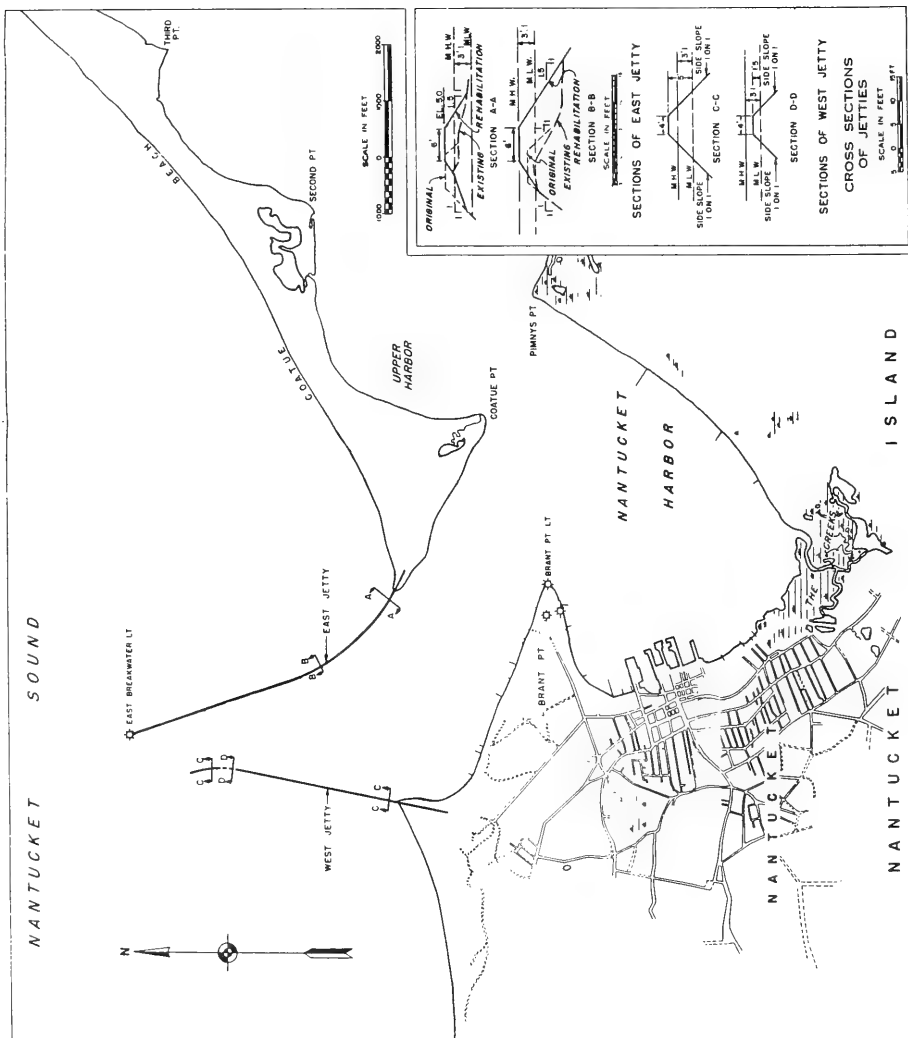
Figure 30. Plan view and typical sections of Nantucket Harbor Jetties, Nantucket Island, Mass.

Date(s)	Construction and Rehabilitation History
1881- 1907	The east and west rubble-mound jetties were constructed to lengths of 6,987 and 4,955 ft, respectively. The jetties converged to a distance of approximately 1,000 ft, with the east jetty extending 800 ft seaward of the west jetty (Figure 30, plan view). Crown elevations were typically +5 ft mlw, side slopes 1V:1H, and crown widths 4 and 6 ft on the west and east jetties, respectively. Approximately 63,000 and 59,000 tons of stone were used in the east and west jetties, respectively.
1917	The outer end of the east jetty was reconstructed for the purpose of mounting a navigation light. A total of 1,790 tons of stone was used for a total cost of \$5,300.
1926	East jetty repairs were made on all but the outer 300 ft of its length. The total repair cost was \$41,600.
1936- 1937	East jetty repairs were made using 15,900 tons of stone at a total cost of \$56,900.

1962- 1963	About 4,400 lin ft of the east jetty was rehabilitated. The repair sections were located from 5+50 to 6+00 and from 8+34 to 52+00. The jetty's seaward end was at approximately 52+75. The design crown width and side slopes were 6 ft and 1V:1.5H, respectively. The landward and seaward sections were raised to +5 and +3 ft mlw, respectively. Minimum stone size was 1.5 tons, with 75 percent of the total stone quantity in pieces weighing a minimum of 2 tons. Prior to repairs, the seaward section had typical crown elevations between +1 and -2 ft mlw. The repairs required 15,100 tons of stone for a total cost of \$181,000.
1967- 1977	Visual inspections indicated the east jetty was in fair condition with some displacement of stone noted. The west jetty was in poor condition, with most of the structure below mhw (+3 ft mlw).
1981	Yearly visual inspections indicated the jetties were in good condition.

1986	Present conditions of the jetties are not known.

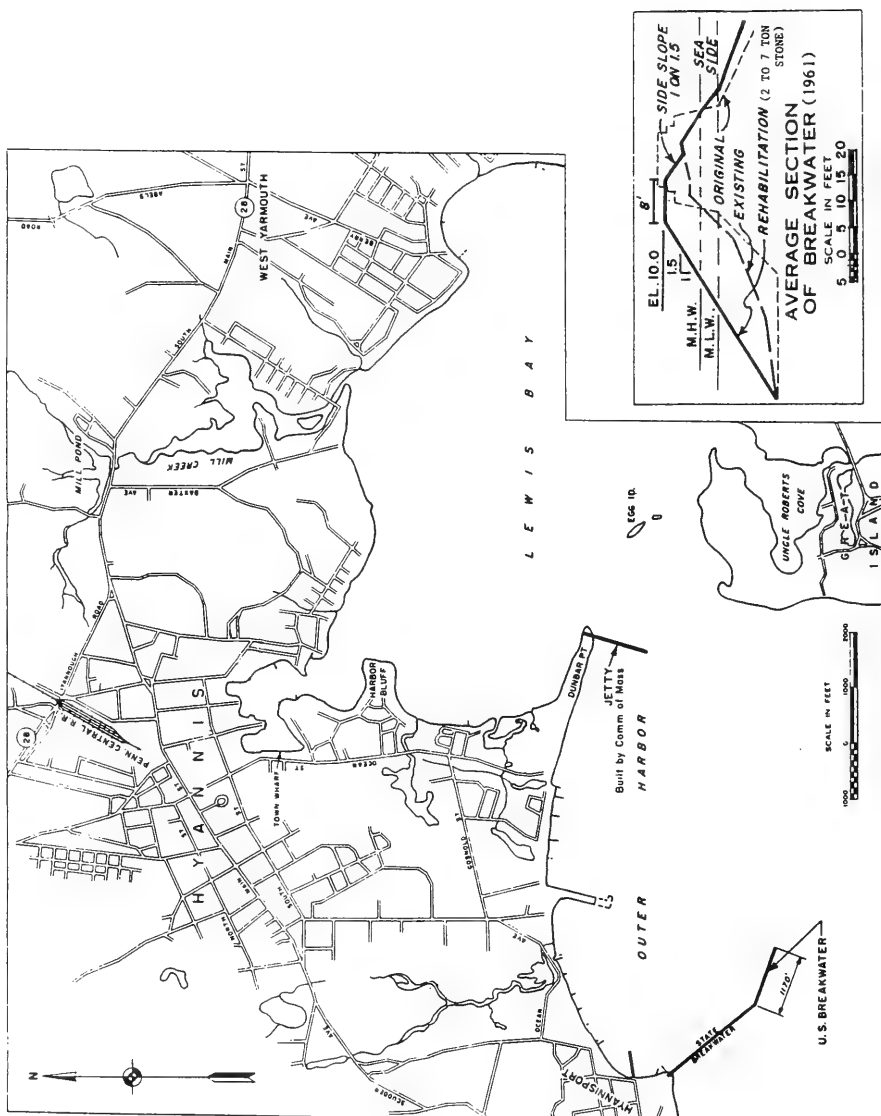
Figure 32. Location map of breakwater at Hyannis Harbor, Mass.

Date(s)	Construction and Rehabilitation History
1827- 1936	The breakwater (Figure 32, plan view) was constructed between 1827 and 1837 and rebuilt between 1870 and 1882. The inner leg of the breakwater, about 2,250 ft long, was built by the State of Massachusetts. The 1,170-ft-long outer leg of the breakwater was built and maintained by the Federal government. The rebuilt cross-section had a 10-ft crown width at +10 ft mlw and may have been of cut stone construction since the side slopes were nearly vertical. Minor repairs were made in 1936.
1950	The outer 1,170-ft-long leg of the breakwater and adjacent 10 ft of state breakwater were repaired with 1- to 6-ton stone. The repair geometry consisted of a 10-ft crown width at +10 ft mlw and 1V:1H side slopes. A total of 3,224 tons of stone was placed for a cost of \$29,200. Prior to the repairs, existing crown elevations varied from +5 to +10 ft mlw. The State portion of the breakwater was considered to be in poor condition.

1961	The outer leg of the breakwater was repaired from 0+00 to 7+80 and 10+75 to 11+15 (breakwater bend at 0+00, seaward end at 11+70). The repair section consisted of an 8-ft crown width at +10 ft mlw, 1V:1.5 side slopes, and 2- to 7-ton armor stone. Before the repairs, crown elevations were from +5 to +10 ft mlw. The repair costs were \$129,800 using a total of 13,588 tons of stone.
1966- 1974	Inspections indicated the Federal portion of the breakwater was in fair condition.
1982- 1986	Yearly visual inspections indicated the breakwater was in good condition.

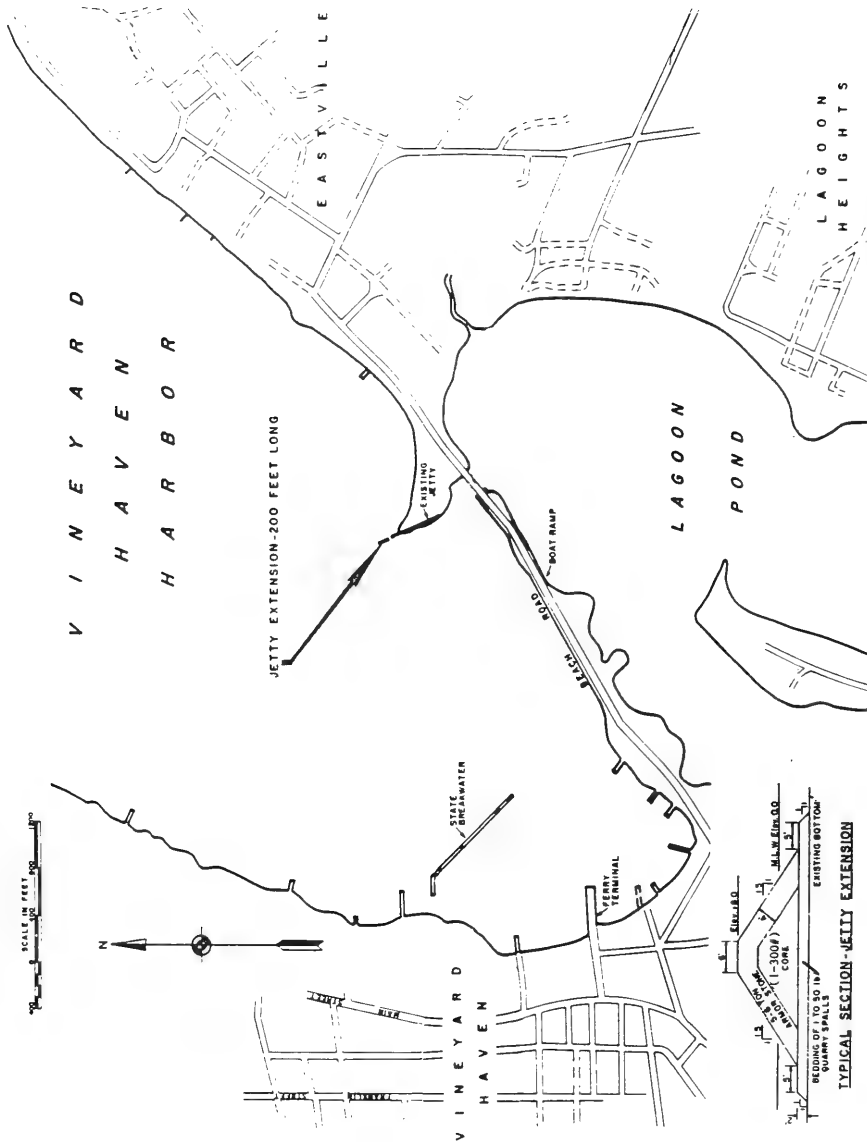
Figure 33. Plan view of Lagoon Pond jetty, Martha's Vineyard, Mass.

Date(s)	Construction and Rehabilitation History
1935	The State of Massachusetts constructed approximately 450 ft of rubble-mound jetty on the east side of the entrance to Lagoon Pond (Figure 33). It appears that the crown elevation and width were +8 ft mlw and 4 ft, respectively. The crown consisted of 4- by 7- by 2-ft granite blocks, and 1- to 5-ton riprap was used on the side slopes.
1973	As part of navigation improvements, to increase harboring areas for the recreational fleet, the jetty was extended 200 ft seaward, terminating at about the -8 ft mlw contour. The landward side of the existing jetty had accreted sediment and created a fillet out to its seaward end. The plan of improvement called for an 8-ft-deep channel into Lagoon Pond and an extension of the jetty to reduce future channel shoaling. The design section called for a 6-ft crown width at +8 ft mlw and 1V:1.5H side slopes. The seaward end had a 1V:2H side slope. The jetty was built with a 2-ft-thick bedding layer of 1- to 50-lb stone, a sand tight core of 1- to 300-lb core stone, and a 4-ft-thick cover layer of 5- to 6-ton armor stone. The design was based on an 8-ft breaking wave height. The contract cost for placing an estimated 5,700 tons of stone was \$98,200.

1974	The jetty and extension were considered to be in excellent condition during a visual inspection.
1982- 1986	Yearly visual inspections of the jetty revealed that it was in good condition.

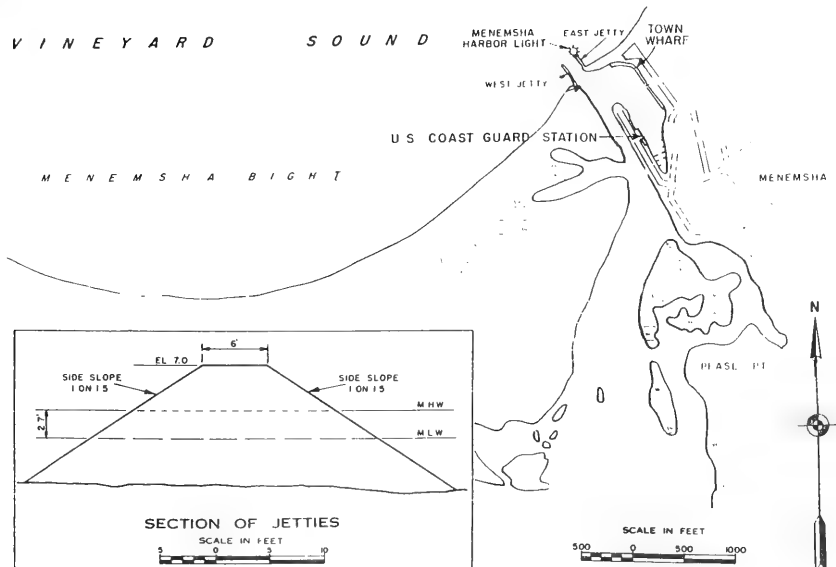
Figure 34. Plan view and typical section of Menemsha Creek jetties, Martha's Vineyard, Mass.

Date(s)	Construction and Rehabilitation History
1945	The east and west jetties, approximately 250 and 435 ft long, respectively, were constructed by non-Federal interests prior to 1945 (Figure 34). The project, adopted by the government in 1945, included maintenance of the riprap jetties.
1969	The west jetty was rebuilt by placing approximately 2,100 tons of cover stone and 900 tons of seal stone. The repairs were made over a distance of 435 ft at a contract cost of \$67,500. The design section consisted of a +7 ft mlw crown elevation, a 6-ft crown width, and 1V:1.5H side slopes.
1981	The east jetty was rebuilt with 20-to 400-lb core stone and 1- to 3-ton cover stone. The design section had 1V:1.5H side slopes and a 6-ft crown width at +7 ft mlw. The contract price for placing an estimated 2,750 tons of stone was \$91,600.
1982-1987	Annual visual inspections of the jetties indicated they were in good condition.

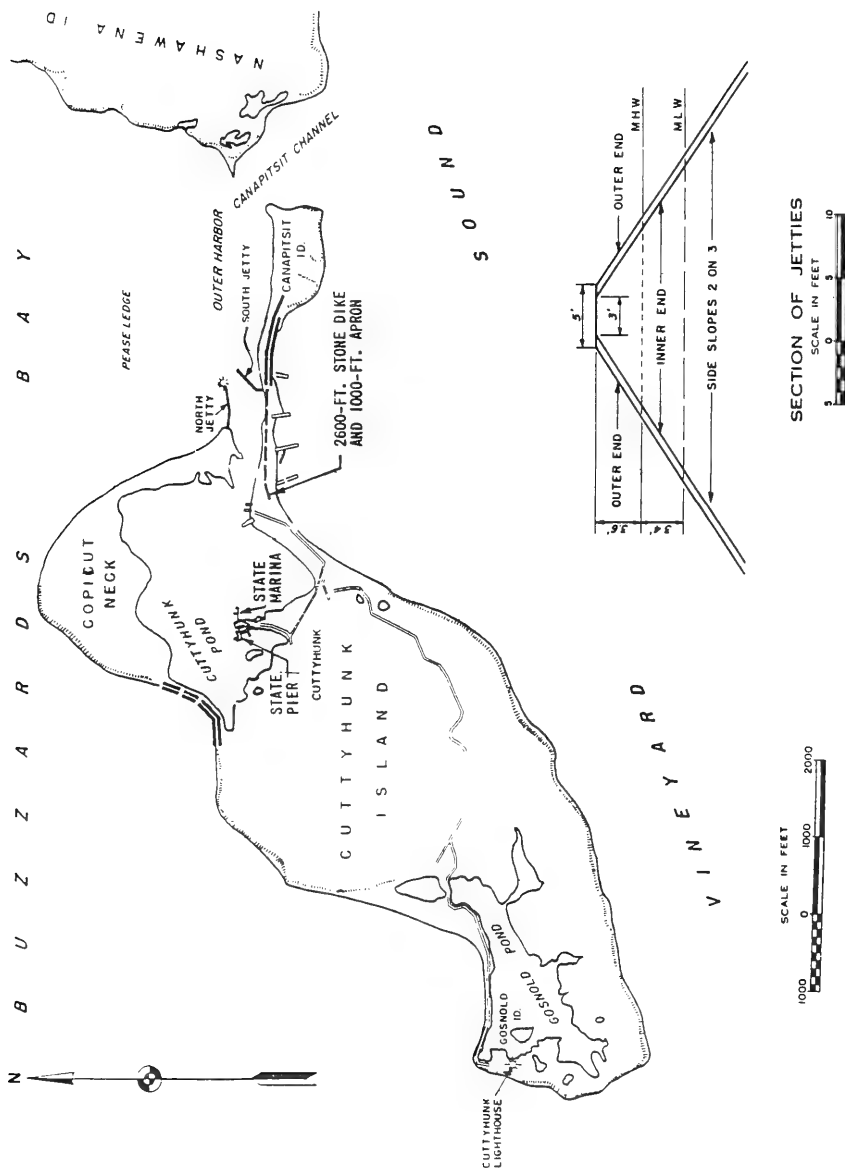
Figure 35. Jetties at Cuttyhunk Harbor, Mass.

<u>Date(s)</u>	<u>Construction and Rehabilitation History</u>
1906- 1935	During this period the north and south rubble-mound jetties, approximately 520 and 280 ft long, respectively, were constructed and maintained by the State of Massachusetts (Figure 35).
1937- 1939	In 1937 the Federal government adopted the Cuttyhunk Harbor Project, which included maintenance of the jetties. In 1939, repairs were made to the north jetty using 500 tons of stone at a cost of \$3,600. The repairs restored the crown elevation to +8 ft mlw.
1951	The north jetty was repaired using approximately 1,800 tons of stone at a cost of \$14,400. The stone ranged in size from 0.5 to 8 tons and was placed to an elevation of +7 ft mlw, 1V:1.5H side slopes, and a 3- to 5-ft crown width.
1962- 1977	Visual inspections indicated the north jetty was in good condition, and the south jetty was in very poor condition. During the early 1960's recommendations were made which included repair of the south jetty, and subsequent repairs were made.

1984- 1986	Annual visual inspections indicated the jetties were in good condition.

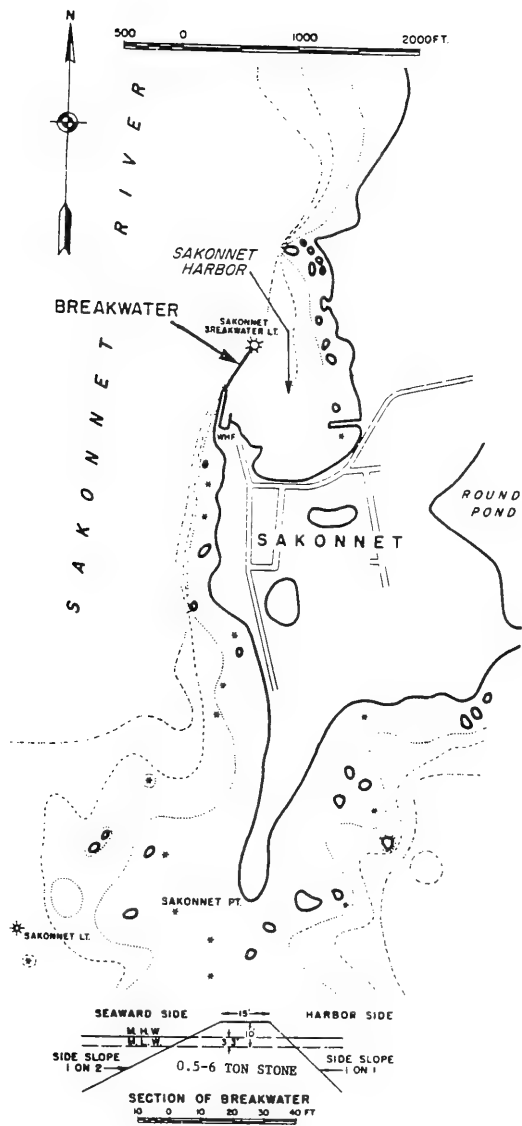
Figure 36. Plan view and typical section of breakwater at Sakonnet Harbor, R.I.

<u>Date(s)</u>	<u>Construction and Rehabilitation History</u>
1836	Two hundred feet of the proposed 400-ft-long rubble-mound breakwater was built for a total cost of \$14,700 (Figure 36, present plan view).
1899- 1901	The breakwater was extended 200 ft seaward to its authorized length of 400 ft. A total of 18,400 tons of stone was placed in the extension at a total cost of \$25,000.
1939	The breakwater was repaired using 1,120 tons of stone at a total cost of \$5,800.
1957	The breakwater was extended 400 ft seaward (Figure 37, aerial photograph), and approximately 800 tons of stone were placed at its landward end. The extension and repair sections were constructed with 0.5- to 6-ton stone placed to an elevation of +8 ft mlw, a 15-ft crown width, and slopes of 1V:2H and 1V:1H on the sea and harbor sides, respectively. A 1V:2H side slope was also used on the head semicircle. The extension was made in water depths varying from -15 to -21 ft mlw. The 150-ft landward repair section included the landward 50 ft of breakwater. The contract cost for placing an estimated 30,000 tons of stone was \$169,500. The remainder of the breakwater was in good condition with center-line elevations of +7 to +9 ft mlw, typical.

1960	A June topographic survey shows cross sections for the entire breakwater approximately 2 ft above the design cross section used in 1957. The reason for the apparent change in datum could not be found (for present report purposes).
1961	Repairs were made on three sections totaling 86 lin ft, including a 25-ft section at the seaward end and 9- and 52-ft sections located approximately 140 and 430 ft from the seaward end, respectively. The repairs were made with 0.25- to 5-ton stone placed to an elevation of +10 ft mlw, a 15-ft crown width, and slopes of 1V:2H and 1V:1H on the sea and harbor sides, respectively. Except for the outermost 15 ft of repairs, which appears to have subsided prior to June 1960, the repair areas were apparently damaged by storm waves sometime between the June 1960 survey and a visual inspection in February. The damaged areas had typically subsided from 3 to 5 ft. The contract cost for placing an estimated 1,200 tons of stone was \$14,400.

1971- 1972	Minor harbor-side slope repairs were made near the landward end of the breakwater. The new riprap was placed for a total cost of \$1400. The overall condition of the breakwater was good, except for some seaside slope stone slippage.

<u>Date(s)</u>	<u>Construction and Rehabilitation History</u>
1974	The landward 485 ft and seaward end of the breakwater were repaired using 3- to 5-ton armor stone and resetting existing stone. Landward repairs were mostly along the seaward side. Repair areas were mostly small, isolated areas of displaced stone which were rebuilt to the grade lines of surrounding sections. The total repair cost was \$28,850.
1977- 1978	Visual inspections indicate the breakwater was in good condition.
1984- 1986	Yearly visual inspections of the breakwater indicated it to be in good condition.

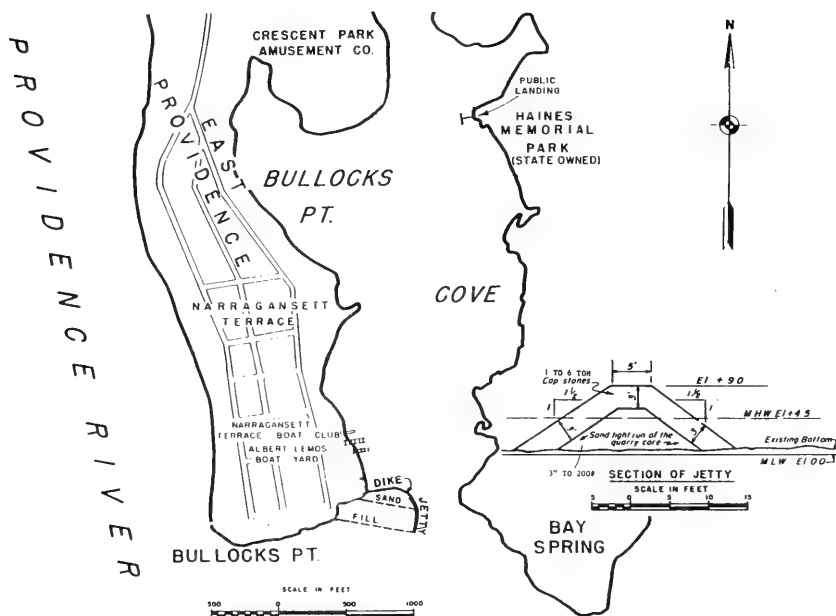
Figure 38. Plan view and design section of jetty at
 Bullocks Point Cove, R.I.

Date(s)	Construction and Rehabilitation History
1958	A 1,000-ft-long combination dike and jetty was constructed on the west side of the entrance to Bullocks Point Cove (Figure 38). The rubble-mound structure was constructed to an elevation of +9 ft mlw. The approximately 300-ft-long jetty had a 5-ft crown width, 1V:1.5H side slopes, a sand-tight core of 3-in. to 200-lb stone, and a cover layer of 1- to 6-ton stone. The contract cost for placing an estimated 10,000 tons of stone in the dike and jetty was \$54,000.
1965- 1977	Visual inspections indicated the dike and jetty were in excellent condition.
1980	An annual visual inspection indicated that the jetty and dike were in good condition.
1986	The present condition of the structure is not known.
